Yaris

Swivel seat
Installation Instructions

Model Year: 2006

Manual reference number AIM 000720-0

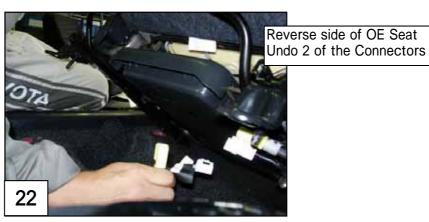
Remove be Driver Seat

Driver Seat Side

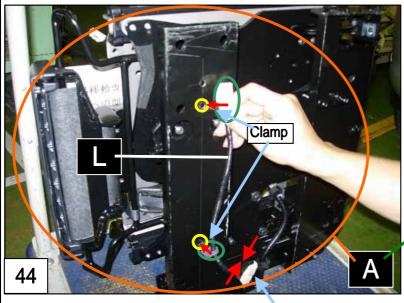
Swivel Seat Installation

Passenger Seat Side

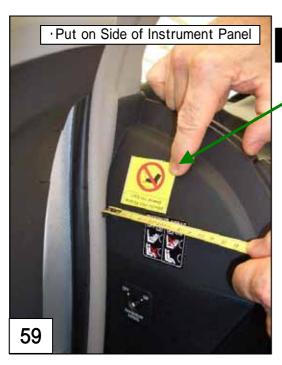
Label putting position

France Only

Put the label on O/M of base Vehicle.

Dispositif de retenue des occupants Sieges enfants

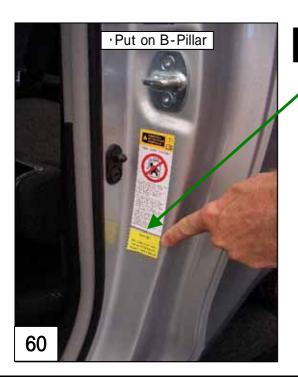
Put the label on O/M of base Vehicle.

Dispositif de retenue des occupants SRS Airbag lateraux
